Epsom rail crossing fatal accident lessons

16 February 2023

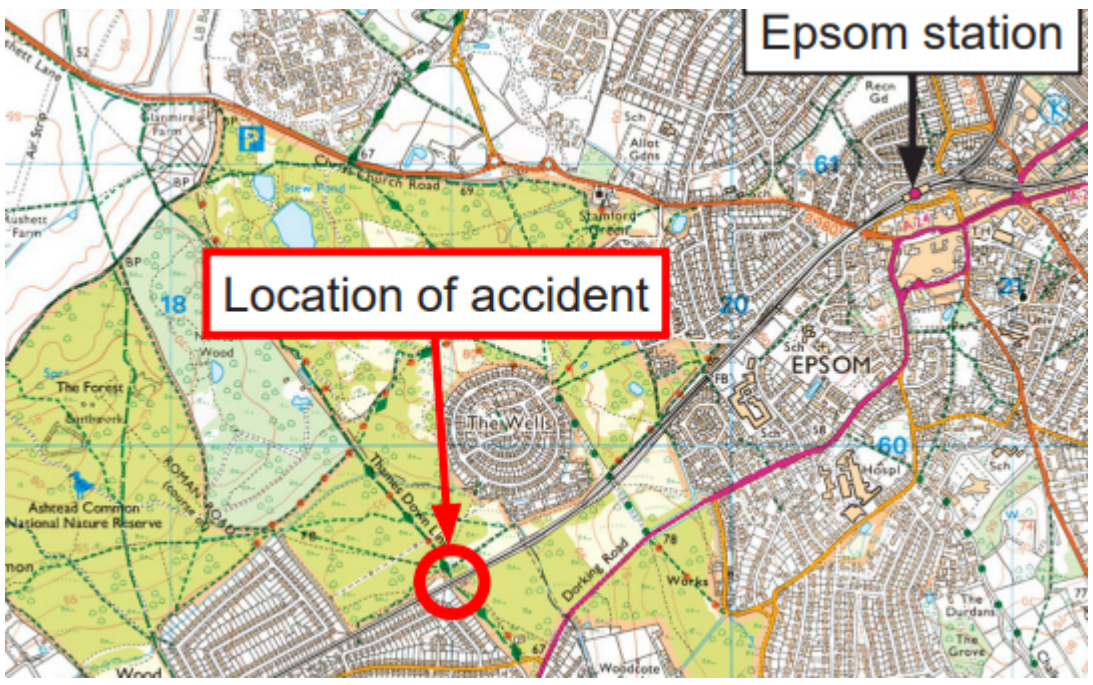
In the afternoon of 21st April 2022, a pedestrian was struck and fatally injured by an out-of-service passenger train at Lady Howard footpath and bridleway crossing on Epsom Common. The pedestrian, who was walking on the crossing with a dog and pushing a wheeled trolley bag, started to cross the railway tracks shortly after a train had passed. She was struck by a second train, which was travelling in the opposite direction to the first. The driver of the train involved in the accident sounded the train's horn on seeing the pedestrian on the crossing. The pedestrian responded by hurrying forwards towards the exit of the crossing, but was unable to get clear of the path of the train in time to avoid being struck.

The investigation found that the pedestrian was apparently unaware that the second train was approaching when she made the decision to cross; there is no evidence that she was aware of it and/or had misjudged the time available to cross. This was because, although the pedestrian looked twice in the direction of the second train before starting to cross, the front of this second train was hidden behind the first train, which was moving away on the line nearest to her. RAIB also found it was possible that the pedestrian did not perceive the risk arising from the possibility that the first train was hiding another approaching train.

A probable underlying factor was that Network Rail had not provided any effective additional risk mitigation at the crossing, despite having previously deemed the risk to users to be unacceptable. Network Rail had planned to install miniature stop lights at the crossing, but complexities with the technology required at this location meant that this solution was not ready for implementation before the accident occurred. There is little evidence that Network Rail considered effective options to mitigate the risk on an interim basis while this solution was progressed, although they fitted additional warning signs for users and a camera to monitor crossing use.

As a result of this investigation, RAIB has made two recommendations, both to Network Rail. The first is intended to address the risk to pedestrians at crossings of this type arising from a second approaching train being hidden from view by another train. The second recommendation concerns the implementation of appropriate interim risk mitigations at level crossings that are awaiting long-term solutions.
