# Accident in Leatherhead led to prosecution

1 August 2026

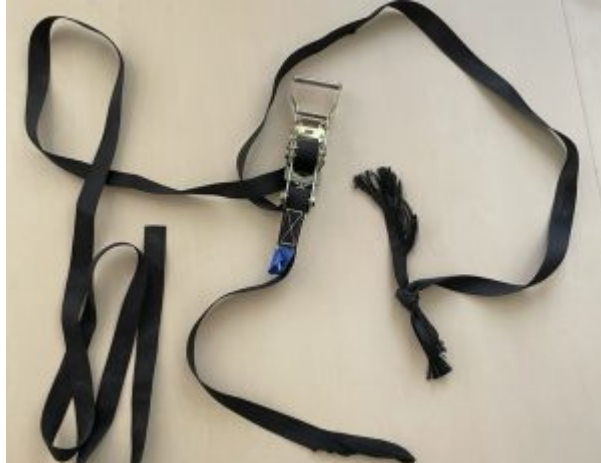
During the dismantling of a steel beam temporary structure, a ratchet strap was being used to lower a steel beam weighing over 100kg. The ratchet strap was not designed for lifting or lowering loads and failed, causing the beam to fall onto Ms McCreith. She sustained multiple fractures to her back, a punctured lung and a broken leg.

Photo: is skate ratchet strap

An investigation by the Health and Safety Executive (HSE) found that iSkate Limited had failed to ensure that the dismantling of the internal steel frame was properly planned and carried out safely.

HSE provides guidance on structural stability during alteration, demolition and dismantling which states that demolition or dismantling arrangements should be written down before the work begins. This safe system of work may be in the form of a safety method statement identifying the sequence required to prevent accidental collapse of the structure.

Speaking after the hearing, HSE inspector Russell Beckett said: “Demolition and dismantling is a high-hazard work activity, but if the work is properly planned it can be carried out safely. This accident has had a devastating effect on Ms McCreith and could easily have been prevented had the right work equipment been used.”
